PHOTO JOURNAL

THE PORTAGEVILLE CHAPEL RESTORATION PROJECT

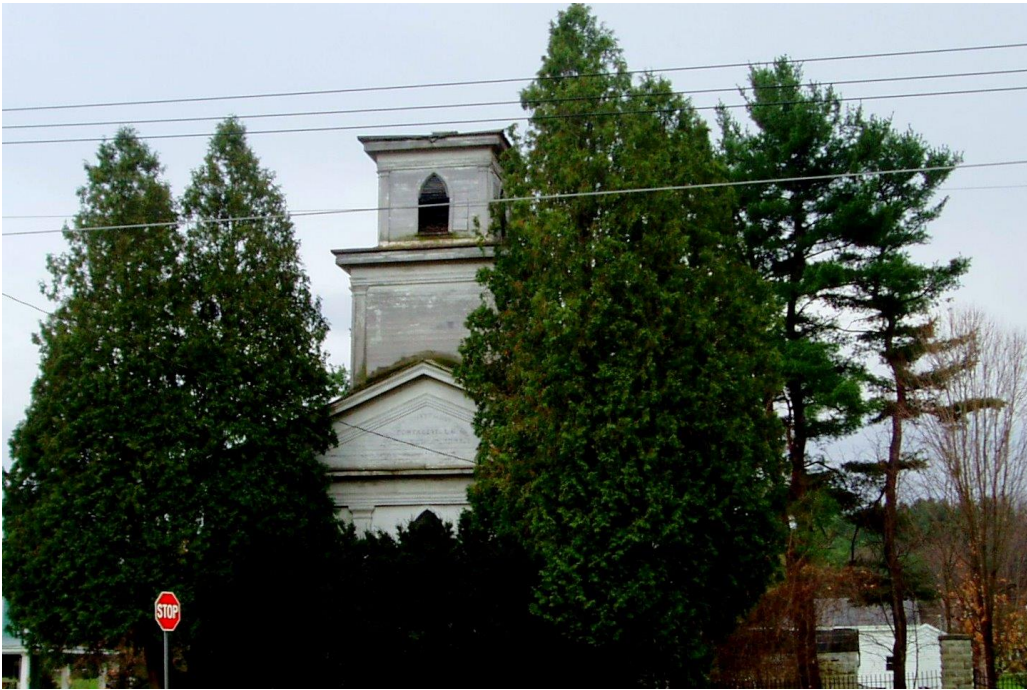
When The Portageville Chapel organization first acquired the property, the front of the building was all but obscured by overgrown trees.

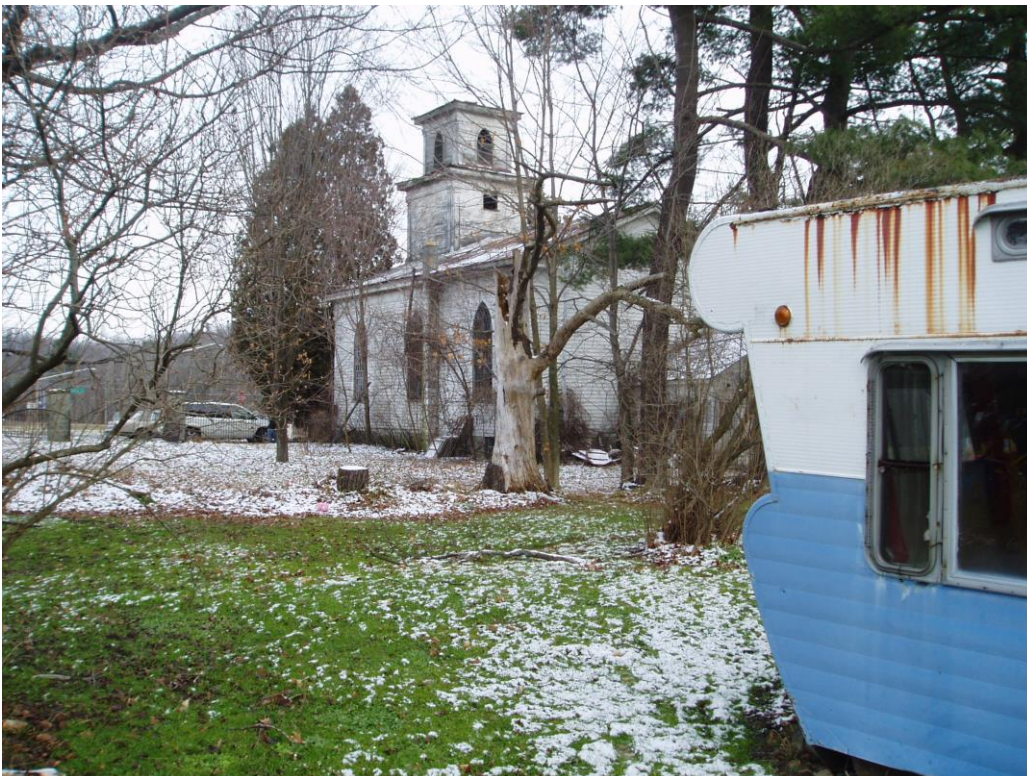
What was visible, was an eyesore.

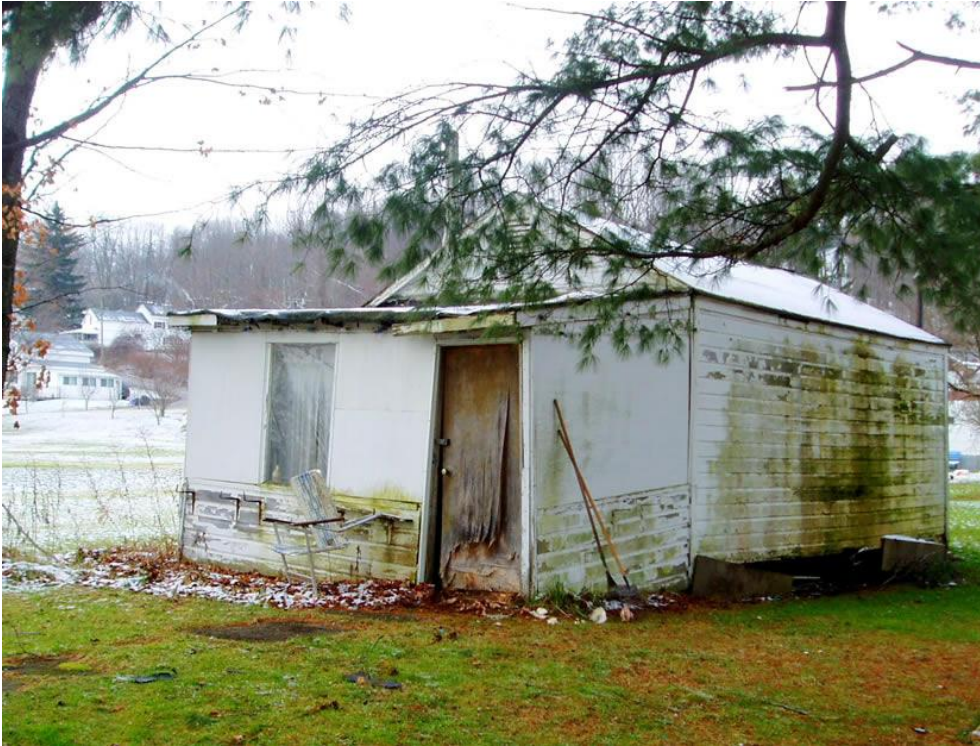
Next to the church, behind the south entrance, there was a dilapidated shack.

The trailer was hauled away and the shack was demolished. The lot was seeded and mowed.

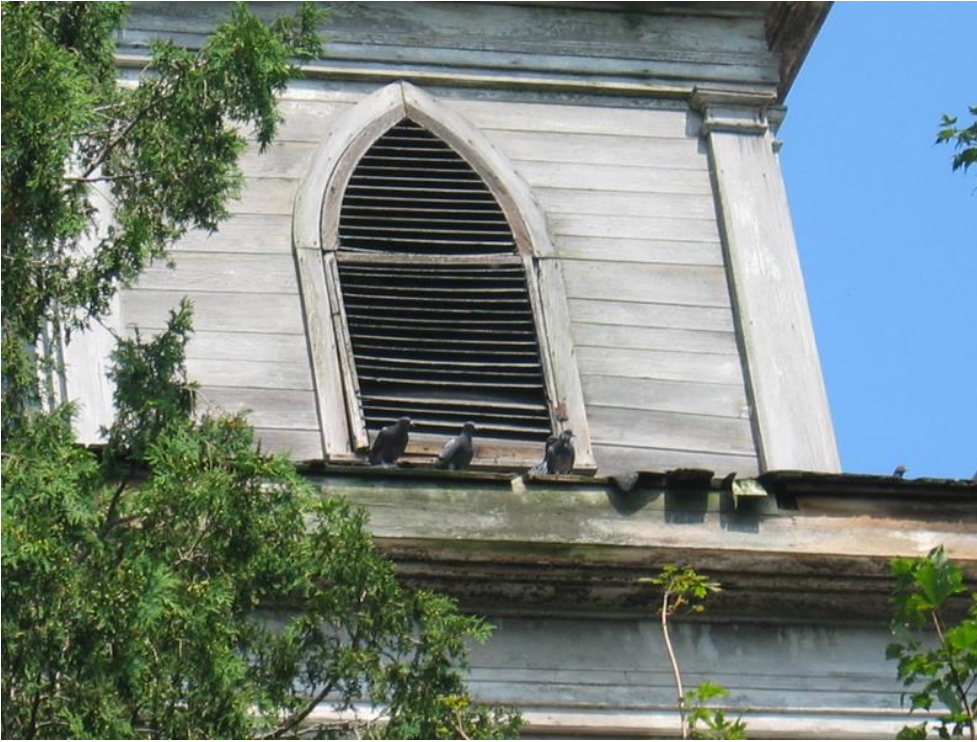
The tower was home to hundreds of pigeons.

The bell tower was cleaned and secured.

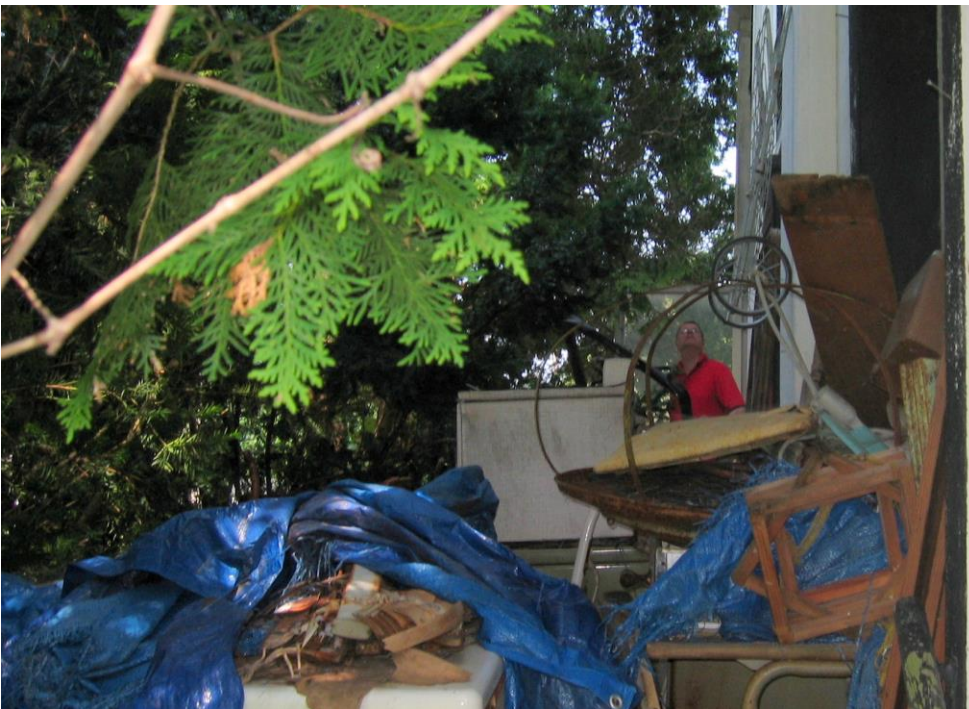
And there was a large accumulation of junk inside and out. For twenty years the building had been used as a shop for secondhand furniture, but the business had been abandoned.

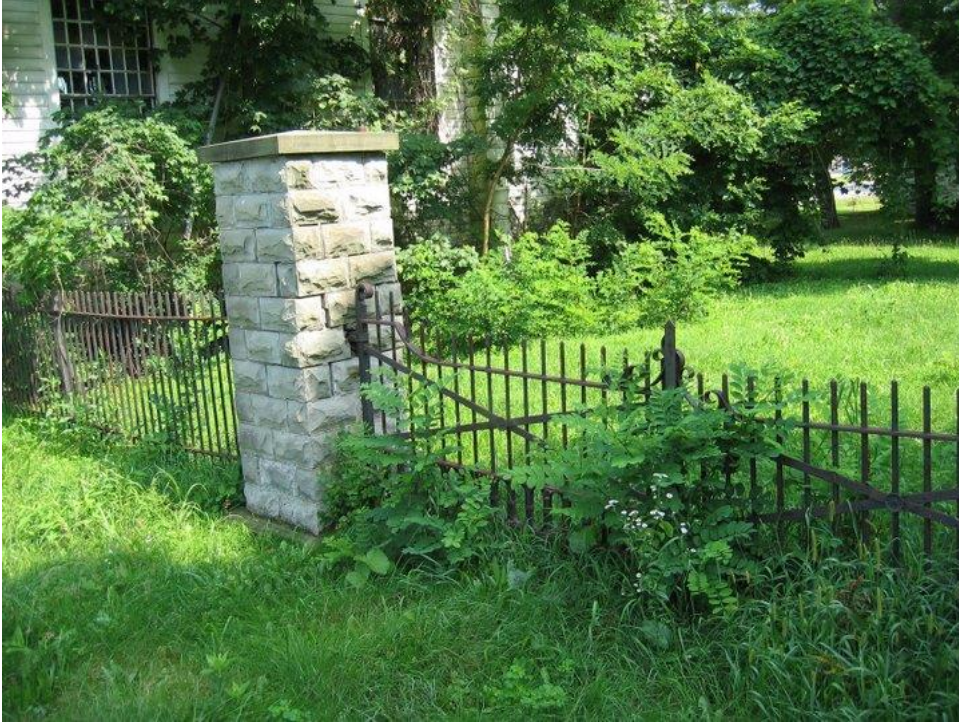
On the west side of the building there was a bluestone and wrought iron fence. Perceiving its value, the sellers tore it down and hauled it away before transferring the title.

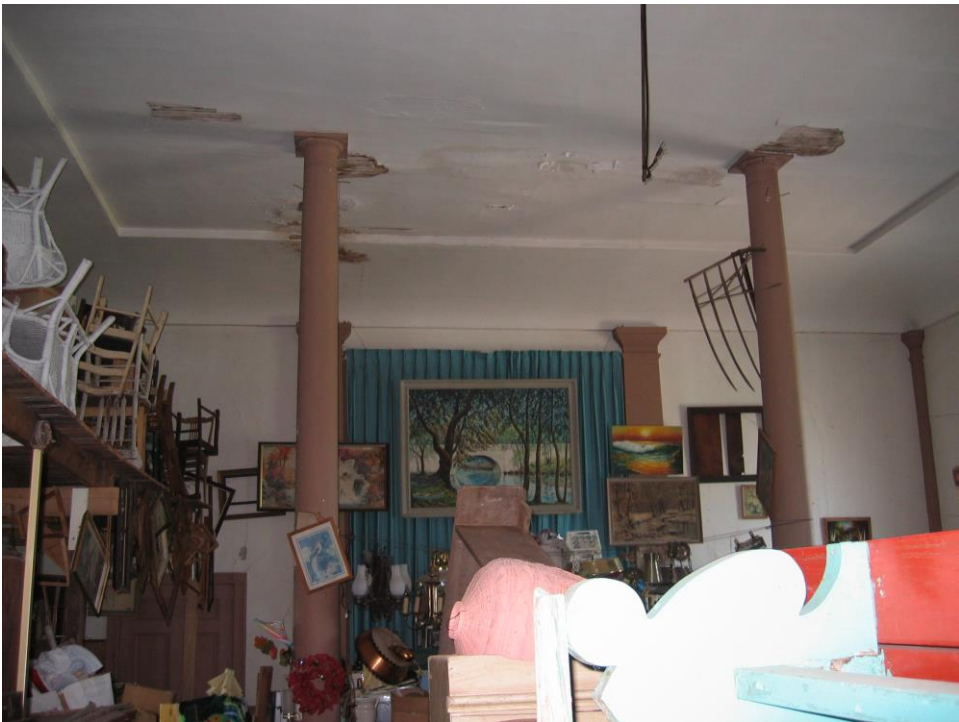
Leaks in the roof had caused damage to the ceiling under the tower area.

In May, 2008, interior painting began. The ceiling was repaired, and the ceiling and cove were primed and painted.

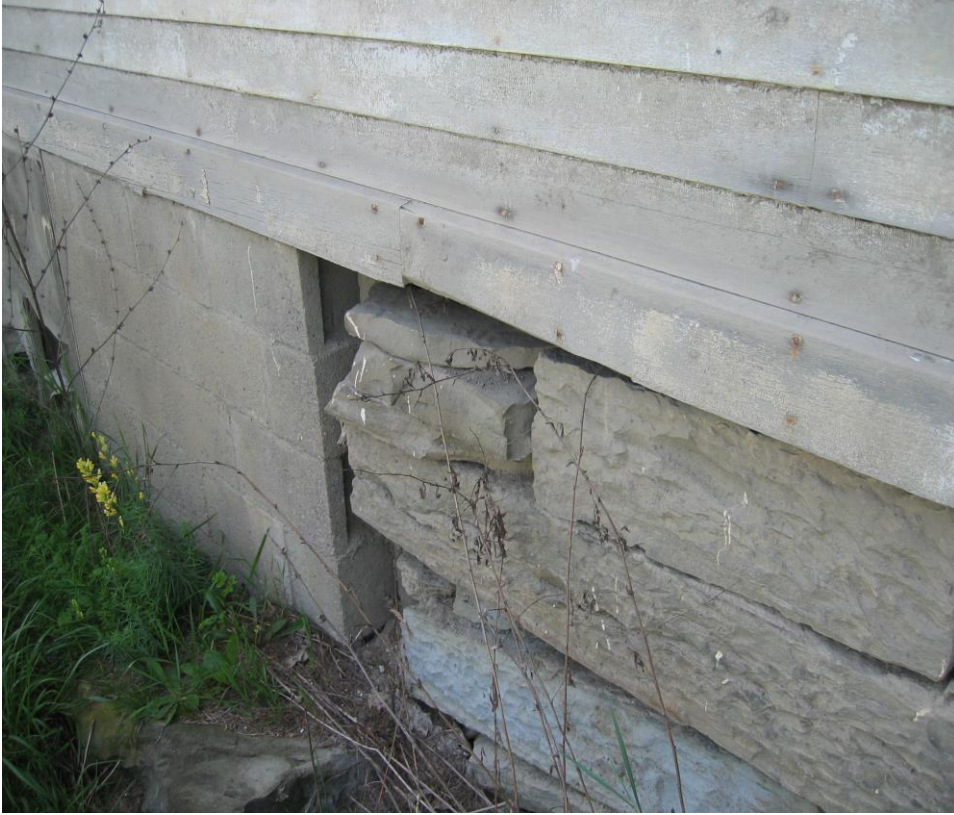
And there were cracks in the foundation.

The foundation was repaired and grading was added to prevent water from entering the basement. The basement was cleaned and wired for shop lighting. The area could now be used as a shop for pew restoration.

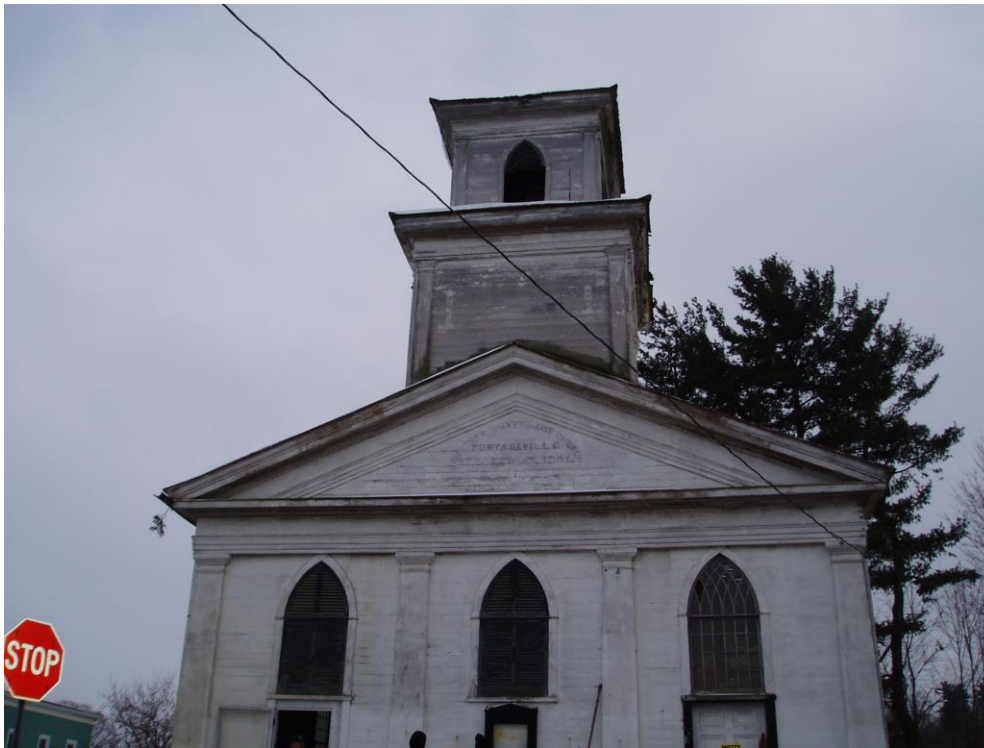
However the building was square and structurally sound, as evidenced by these two photographs taken in February 2007, just after the overgrown trees in the front were cut down.

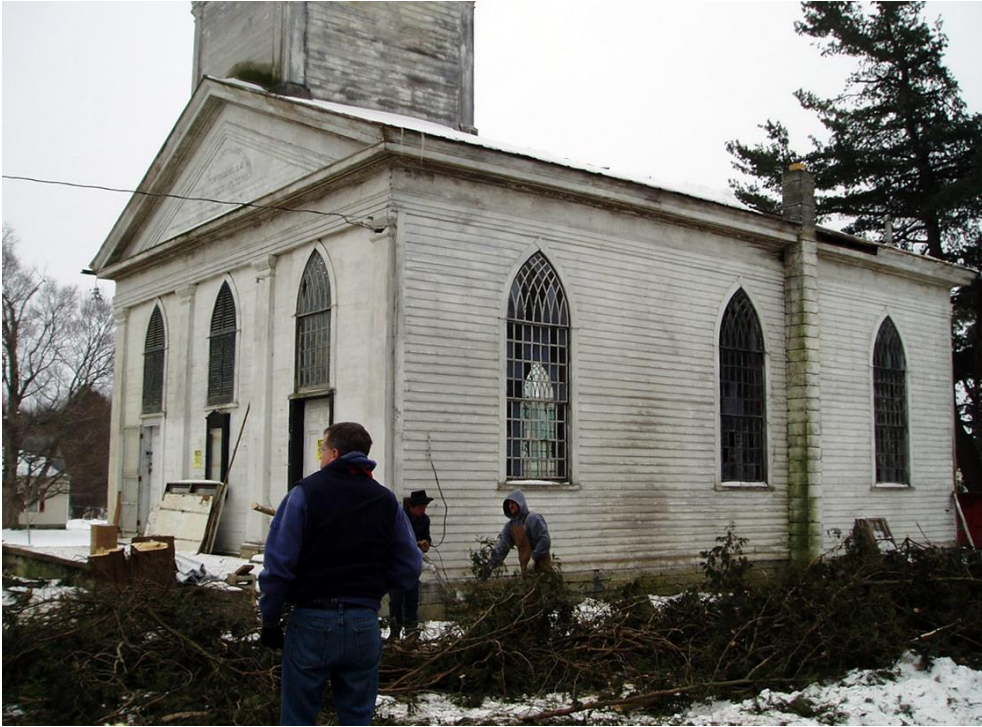
The original clapboards were in good condition, although they had not been painted since 1951.

The exterior of the building was painted.

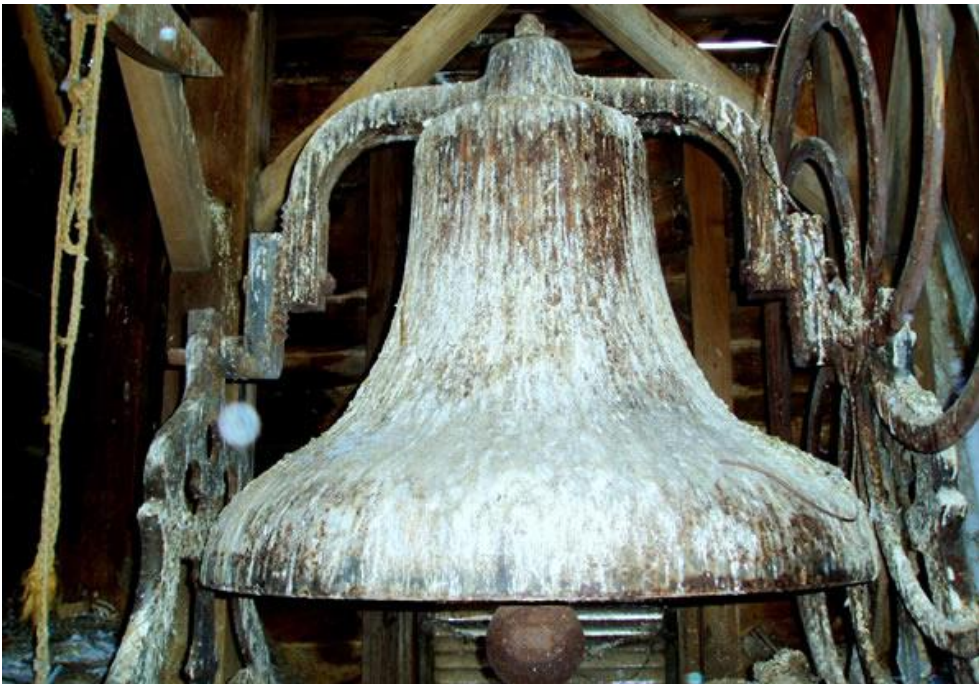
The original bell was intact but needed new ropes and mechanics.

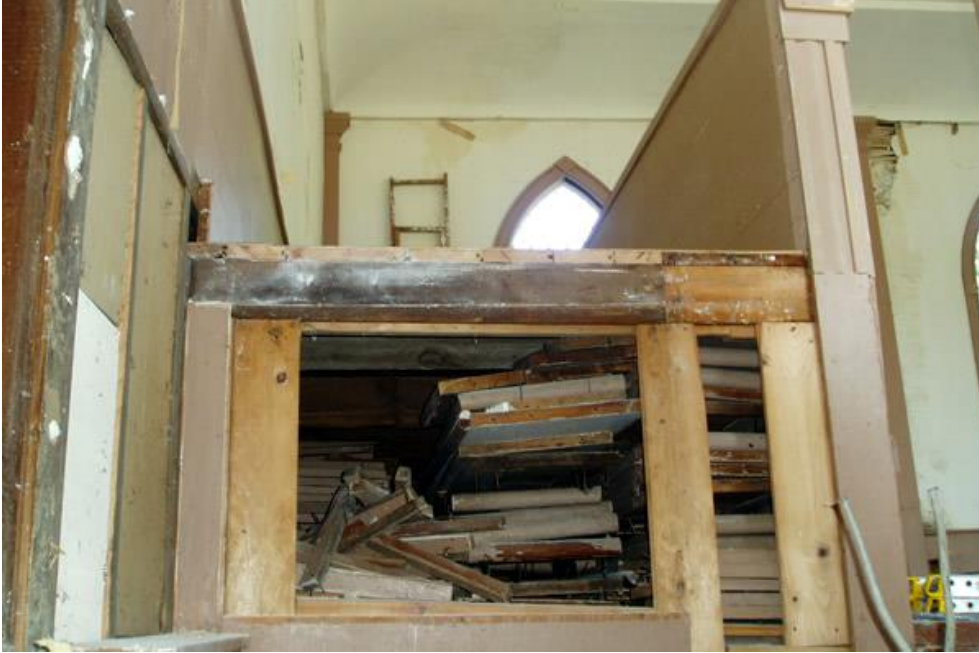
The original pews had been taken apart and stored. An inventory revealed that all of the pews and pew doors were present.

Pew restoration began simultaneously. Pews and pew doors were sanded, primed and painted white. The mahogany trim was refinished.

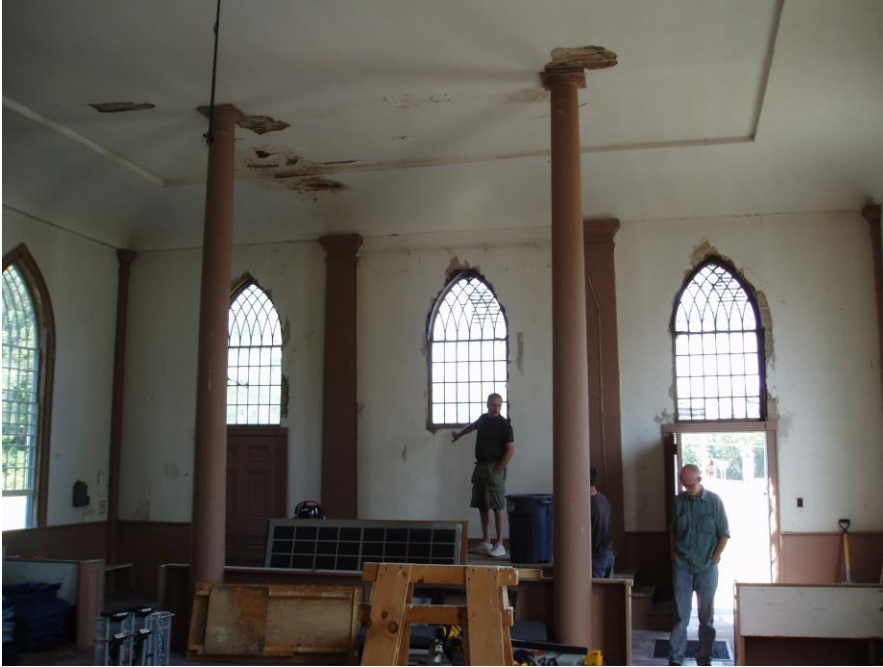
The three windows on the front of the building had been covered with plaster. They were hidden from the interior for over 100 years.

David Lewis uncovered the windows and restored them in Holden, creating new interior frames to match the other six windows.

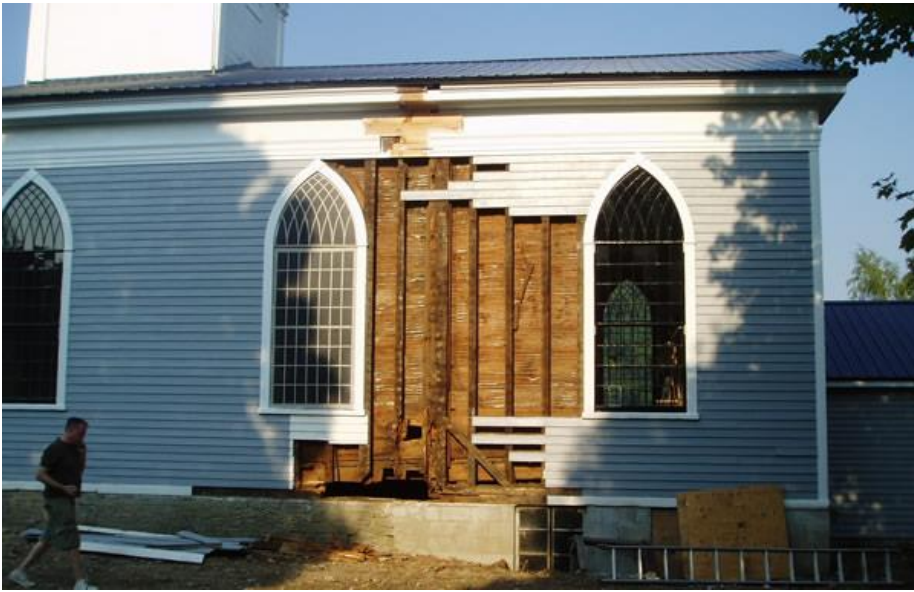
While repairing water damage to the interior walls, it was discovered that the makeshift chimney installed during the 50s had allowed water to rot a support post. The clapboards were removed to expose the damage.

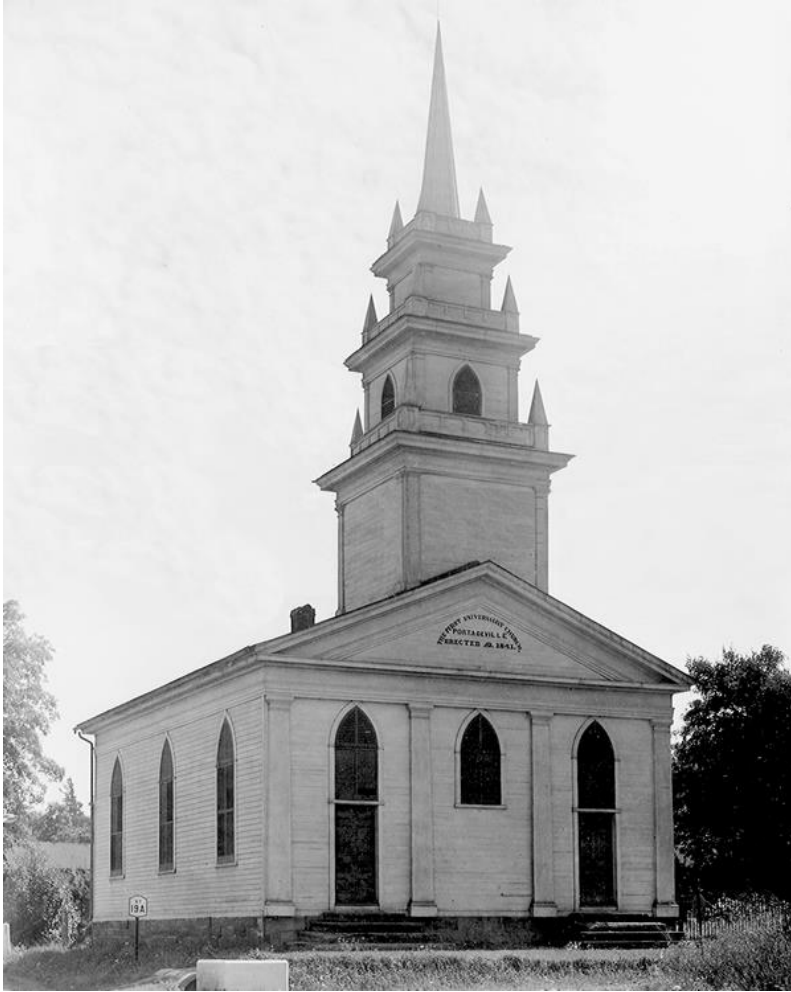
This is the earliest known photograph of the building, taken in 1931. It shows the spire, which was allowed to deteriorate despite efforts of township officials to save it. The top section of the tower and the spire were lost in a wind storm in the summer of 1951. It is the goal of The Portageville Chapel organization to restore the spire in the future.
